PROTECTING SURFACE WATER RESOURCES THROUGH SILVICULTURAL METHODS

Cristinel Constandache¹, Lucian Dinca¹, Nicu Constantin Tudose¹, Casen Panaitescu²

¹National Institute for Research and Development in Forestry (INCDS) "Marin Dracea, 1 – Focsani Station, 7 Republicii, cicon66@yahoo.com, 2,3 – Brasov Station, Closca street, dinka.lucian@gmail.com; cntudose@yahoo.com, Romania

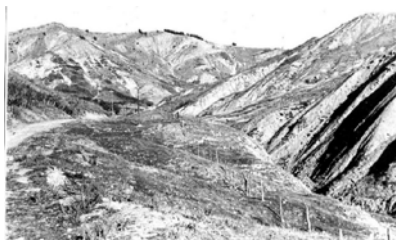
Figure 1. Scaune-Valea Sarii Perimeter before afforestation (photo Costin 1954, INCDS „Marin Dracea” archive)

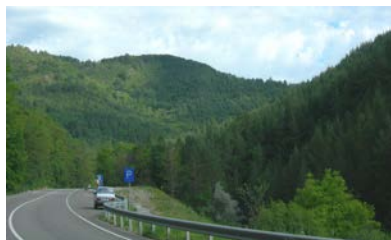
Figure 2. The same perimeter but afforested (photo Constandache 2012, INCDS „Marin Dracea” archive)

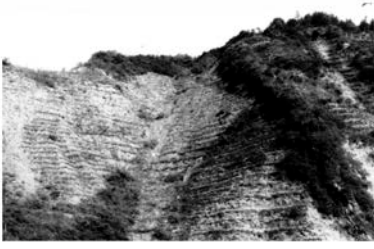
Figure 3. Consolidation of degraded lands with "vegetally armed" terraces (photo Untaru 1979, INCDS „Marin Dracea" archive)

- vegetally armed terraces (Figure 3) in most eroded, clough lands and detachment ramps from areas in which white sea buckthorn is naturally installed; the white sea buckthorn stems, branches and roots used for constructing terraces have entered in vegetation in a high percentage (50...70%), leading to the formation of vegetal belts that play a significant role in dissipating and stopping superficial drainage and in stopping soil erosion; furthermore, this method has led to a considerable cost reduction (with almost 60%) in comparison with other methods, while the definitive success of the achievement's duration was reduced with at least two years (Traci & Untaru 1986); in plantations realized on vegetally armed terraces (Figure 4) the growth of planted species (Black pine and/or Scots pine) were also considerably higher in comparison with other types of works (Constandache et al 2016, Silvestru-Grigore et al 2018); this fact is explained by the higher capacity of water retention and the soils enrichment with nitrogen resulted from white sea buckthorns (Untaru et al 2013, Dinca et al 2018).

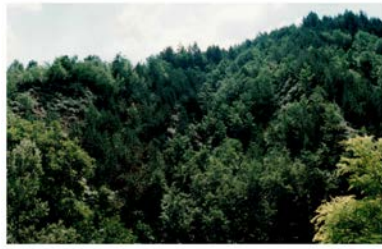
Figure 4. The same terrain after approximately 35 years (photo Constandache 2015, INCDS „Marin Dracea" archive)
